Hazardous Materials Release From Railroad Tank Car With Subsequent Fire at Riverview, Michigan July 14, 2001

**Hazardous Materials Release
From Railroad Tank Car With
Subsequent Fire at
Riverview, Michigan
July 14, 2001**

**NTSB/HZM-02/01
PB2002-917002
Notation 7400A
Adopted June 26, 2002**

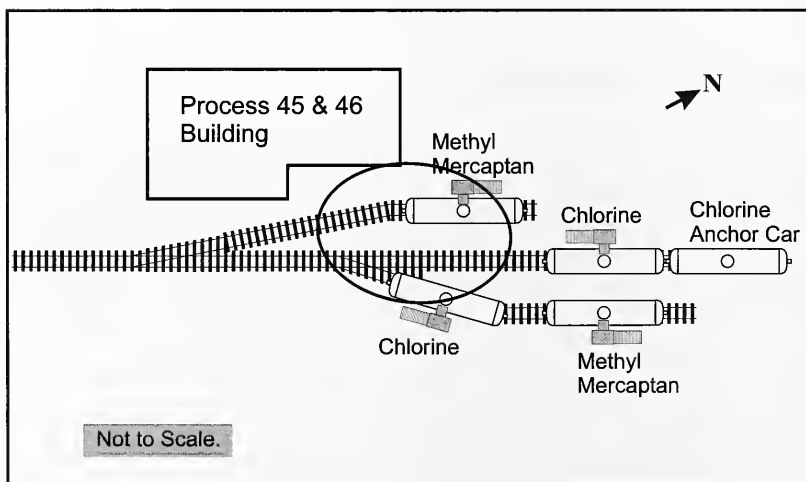
Figure 2. Accident site. (The circled area is the area of greatest fire damage.)

Damage to the plant was limited to fire exposure on the methyl mercaptan unloading station, which resulted in melting or damaging most of the non-ferrous fittings, gauges, and other apparatus; fire exposure and warping of the track under the methyl mercaptan tank car; and scorching of track ties and nearby wooden planking.

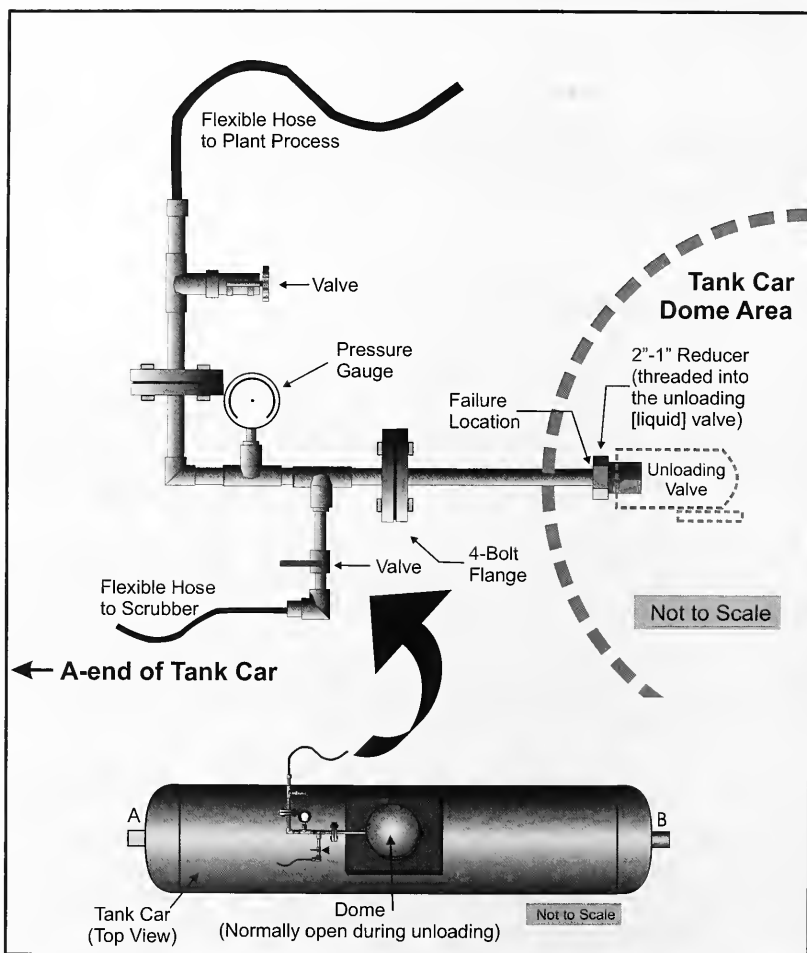
The first component of ATOFINA’s unloading apparatus consisted of a 1-foot-long, 1-inch-diameter steel pipe with a 2- to 1-inch reducer threaded onto one end and a four-bolt flange threaded onto the other. In preparation for product transfer, the reducer end of the pipe was passed through an access hole on the side of a tank car dome, and the reducer was threaded onto the tank car’s unloading valve. The 1-inch pipe was the one that, in this accident, failed and separated, releasing the methyl mercaptan.

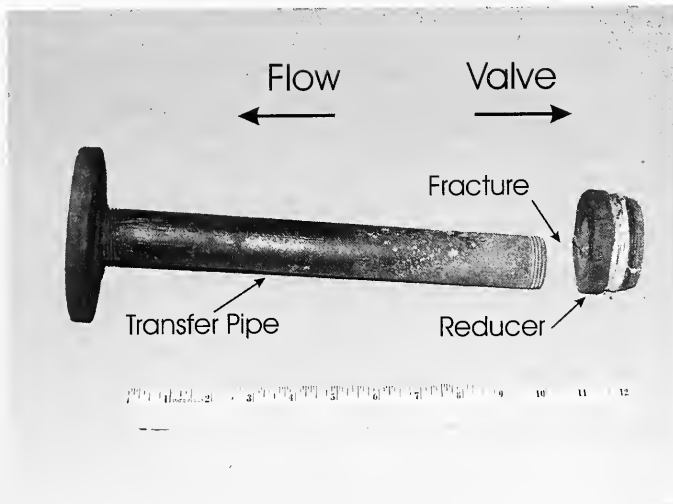
Figure 5. Separated transfer pipe.

As noted earlier, a 1-inch-diameter steel pipe in the unloading apparatus of UTLX 900558 was separated at the point the pipe threads exited a 2- to 1-inch reducer installed in the tank car's unloading valve. The flexible hoses attached to the unloading apparatus on both tank cars were melted and partially consumed by the fire.

The Safety Board's metallurgical examination of the separated steel pipe in the unloading apparatus (figure 5) did not identify any evidence of preexisting cracks on the fracture surface; the fracture features were typical of an overstress separation. Examination of the pipe revealed evidence of corrosion, including deposits of iron oxide (rust) and pitting on both interior and exterior surfaces. (The interior surfaces of the pipe were exposed to the weather whenever the unloading apparatus was not in place on a tank car.)

Measurements of the interior and exterior diameters at several locations on the length of the pipe were compared with interior and exterior diameters for new pipe. These comparisons revealed that the outside diameter was comparatively the same as that of new pipe; however, the inside diameter near the end of the pipe where the failure occurred showed evidence of erosion-corrosion damage (discussed in the next section) that reduced the wall thickness near the fracture by about 23 percent as compared to the inside diameter of new pipe.

Calculations made using the weight of each of the unloading apparatus components, their distances from the pipe separation, the standard (as manufactured) wall thickness of 1-inch pipe, and standard piping design and engineering formulas indicate that bending stresses on a new pipe at the point the pipe entered the reducer would have been 20,800 pounds per square inch (psi). The wall thickness reduction of the accident pipe that resulted from erosion-corrosion resulted in a 20-percent increase in the calculated bending stress on the pipe, to 25,100 psi at the point of fracture. Comparing the bending stress to the strength of the material, Safety Board metallurgists estimated that an additional force of about 175 pounds (added to the existing force represented by the weight of the unloading apparatus), if applied at the outer end of the unloading apparatus, would cause an overstress failure (fracture) of the pipe.
